18 May 2016

Sealing systems used in watertight cable penetrations

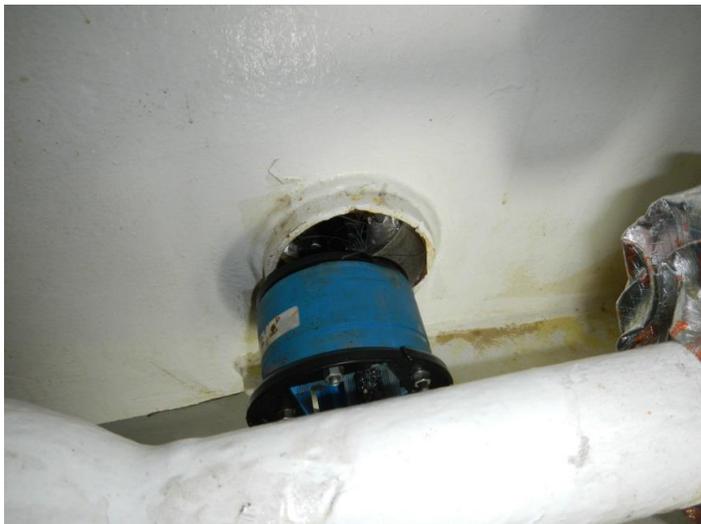
Some of the cable penetrations did not withstand the water pressure and “popped out”. Others were leaking, extending the flooded area of one pontoon and the damage to expensive equipment.

Figure 3: MCT that popped out by water pressure.

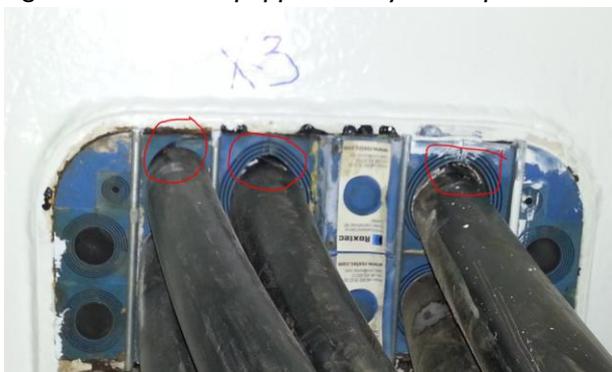
Figure 5: Visible gap between cables and module halves.

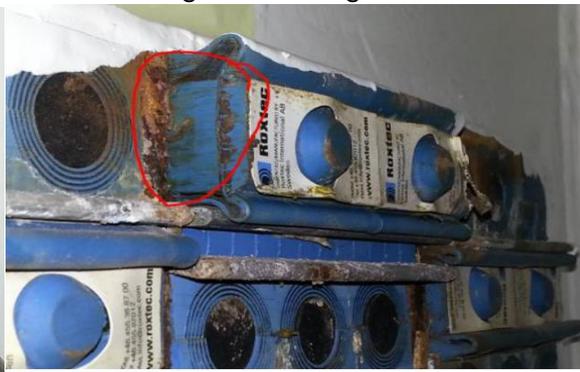
Figure 6: Wedges are not tightened

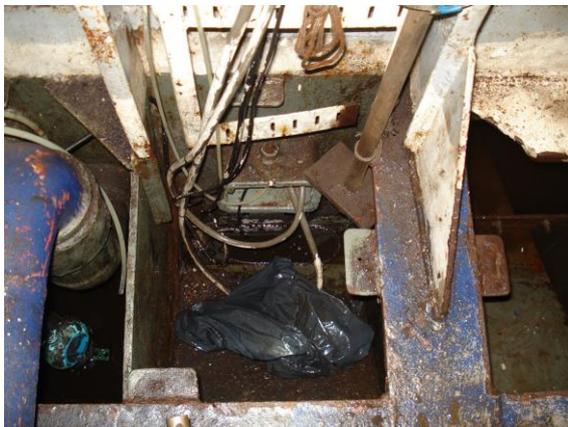
The first investigations indicated that the leakage could have originated in or in connection with the steering gear room aft. However, later investigations established that the water ingress originated from the emergency fire pump under the fo'c'sle, wherefrom it had penetrated the first water tight bulkhead and filled up the tunnel, before it penetrated the second watertight bulkhead entering into the engine room. It was also revealed that the cable openings in the mentioned bulkheads probably had not been equipped with any water tightening sealing at all when the vessel was rebuilt in 2002.

Figure 7: Bilge alarm and cable duct through the bulkhead on frame 112 – not sealed

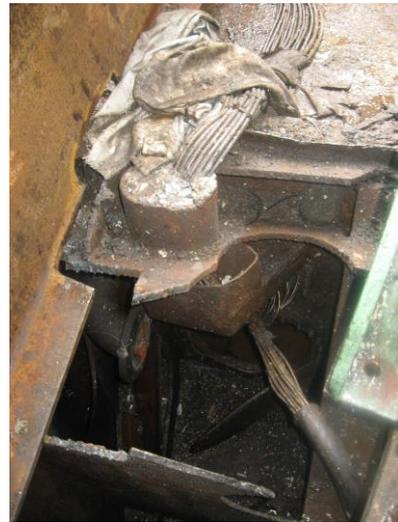
Figure 8: Engine room bulkhead cable duct - not connected to deck and not sealed
